10-YEAR PAINT TESTS ON WEATHERED GALVANIZED ROOFING

By A. J. Muehling and J. O. Curtis

UNIVERSITY OF ILLINOIS
AGRICULTURAL EXPERIMENT STATION

August, 1961

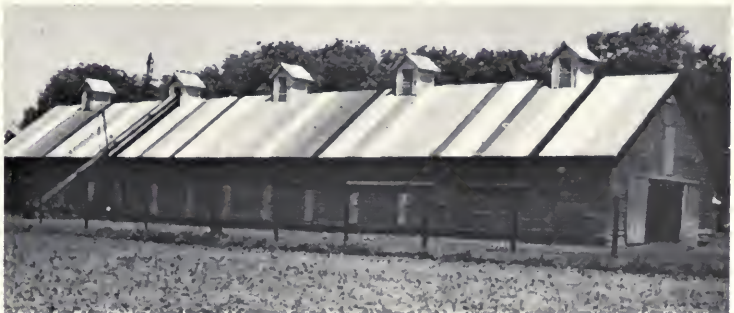
COVER PHOTO — *the 150-foot corn crib on which the paint study was conducted (south side after application of first coat of paint).*
